Manhole Inspection Summary

Manhole # S21I1_021MH

Insp Date: **5/5/08 8:43 AM**

Location Address: **2700 wegworth la**

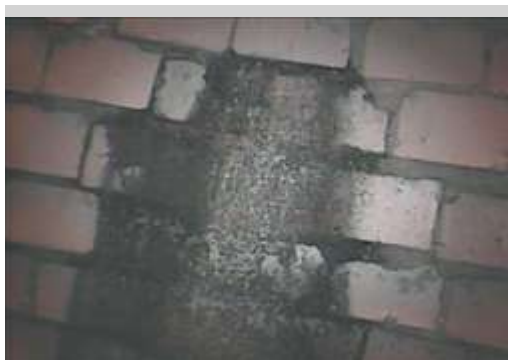
Defect 4

Infiltration: ☐ None ☐ Joint ☐ Cracks ☒ **Mortar** ☐ Roots ☒ **Wall**

infiltration @ barrel wall

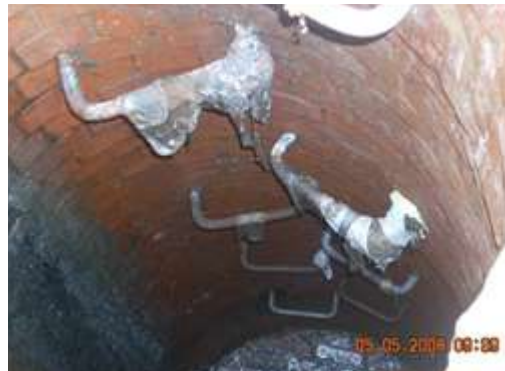
Defect 3

Surcharge ☒ **Evidence Of Surcharge** Depth: **8** (ft.) ☐ Active Surcharge Present

surcharge evidence

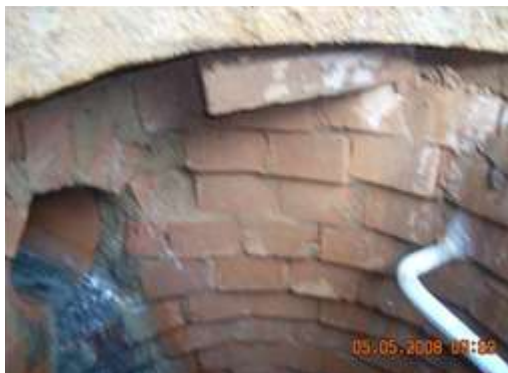
Defect 2

Condition: ☐ Sound ☐ Cracked ☐ Root Intrusion ☒ **Loose Brick** ☐ Deteriorated

loose chimney brick

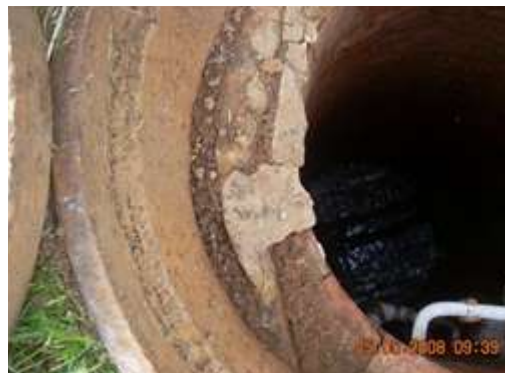
Defect 1

Frame Offset: **5** (in.) Condition: ☒ Sound ☐ Cracked ☐ Leaks

frame offset

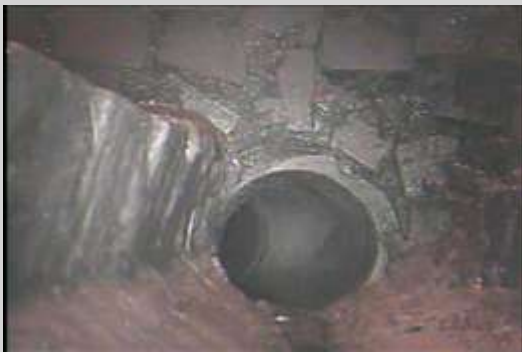
12 O'Clock Outflow

8 in. Circular Gravity Sewer
Pipe Out @ 12 O'Clock

Pipe Height: **7.2** (in.) Rod and Bar (Angled)
Pipe Material: **Clay** ☐ Pipe Lined
Invert Depth: **13.70** (ft.) Flow Characteristics: **Slow**
Deposits: ☒ None ☐ Mud ☐ Sludge ☐ Debris ☐ Grease
Silt Depth: **0** (in.) Deposits Extent:
Infiltration: **Evidence** Pipe Seal Cond: **Sound**

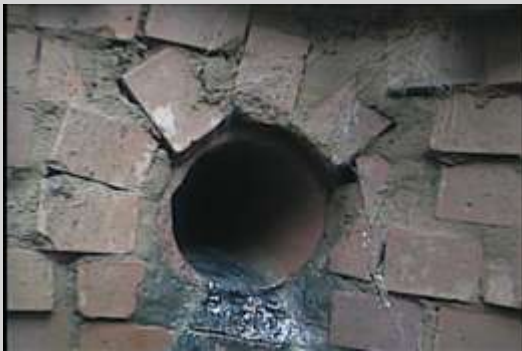
6 O'Clock Inflow

8 in. Circular Gravity Sewer
Pipe In @ 6 O'Clock

Pipe Height: **7.2** (in.) Rod and Bar (Angled)
Pipe Material: **Clay** ☐ Pipe Lined
Invert Depth: **0.00** (ft.) Flow Characteristics: **None**
Deposits: ☒ None ☐ Mud ☐ Sludge ☐ Debris ☐ Grease
Silt Depth: **0** (in.) Deposits Extent:
Infiltration: **Evidence** Pipe Seal Cond: **Cracked**

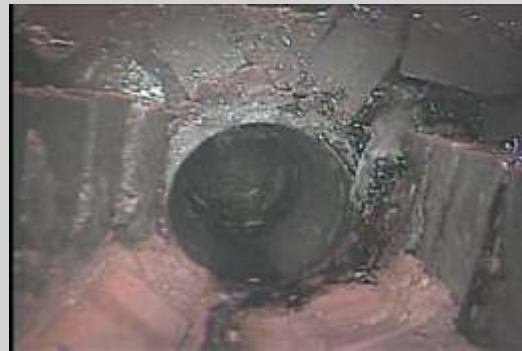
Drop In @ 6 O'Clock

Drop: **Outside** Rod and Bar
Angled: **Yes** Reading: **12.45** (ft.)
Inv Depth: **13.45** (ft.)
Drop Condition: **Clogged**
